REMEDIAL ACTION CONSTRUCTION SUMMARY REPORT

DEMOLITION AND REMOVAL

MCCORMICK & BAXTER CREOSOTING COMPANY
PORTLAND, OREGON

Task Order No. 71-03-21

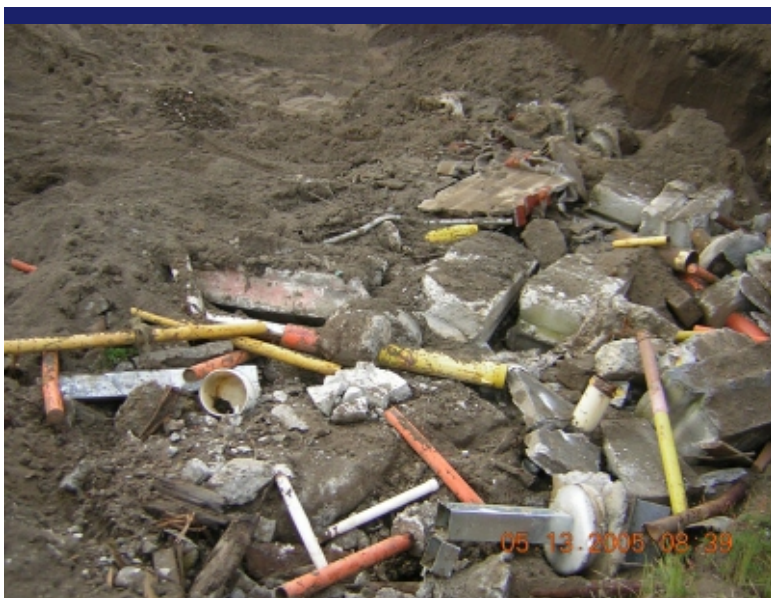
Photo 1 On-site disposal pit.
Direction:

Concrete originating from the old shop building slab, tank supports, and miscellaneous areas was broken into pieces and transported to an on-site debris disposal area for burial. The debris disposal area was moved from the design location to a location just northeast of the “Buried Concrete Debris” area shown in the drawings.

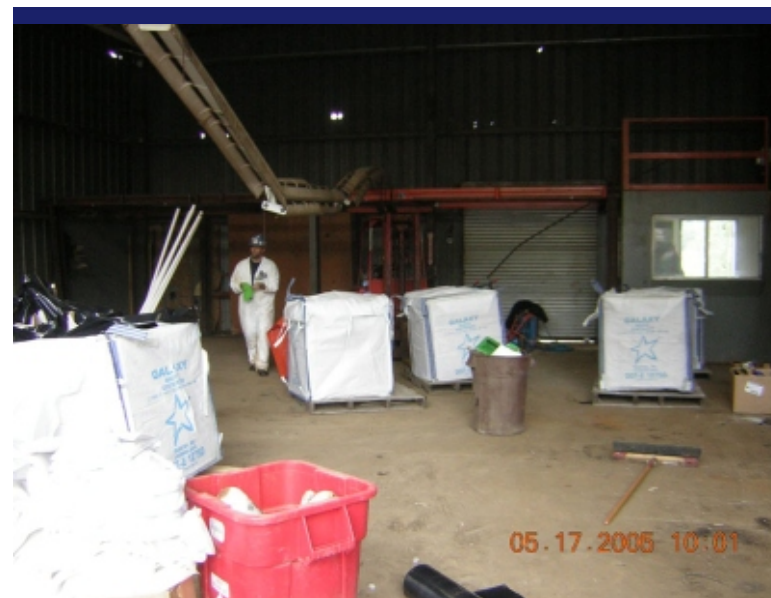
Photo 2 Hazardous material from shop building being placed in super sacks for off-site disposal.
Direction: Southwest

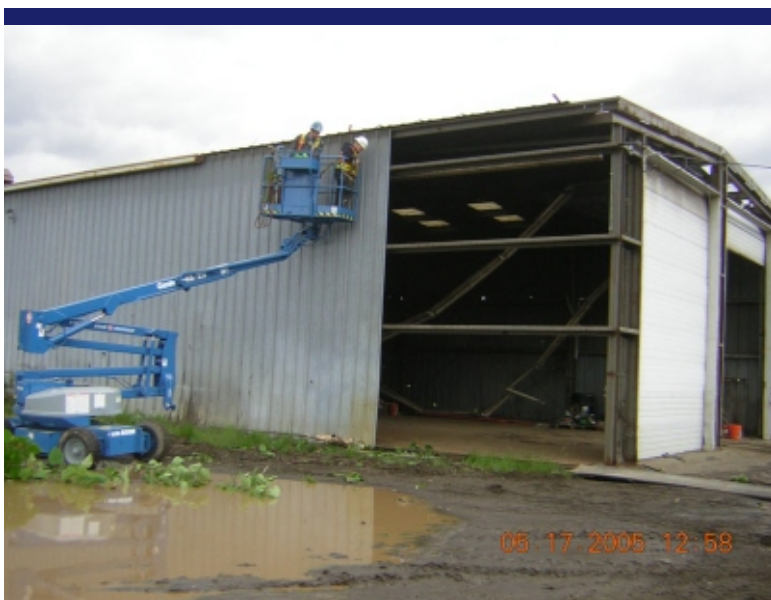
Photo 3 Shop siding being removed.
Direction: West

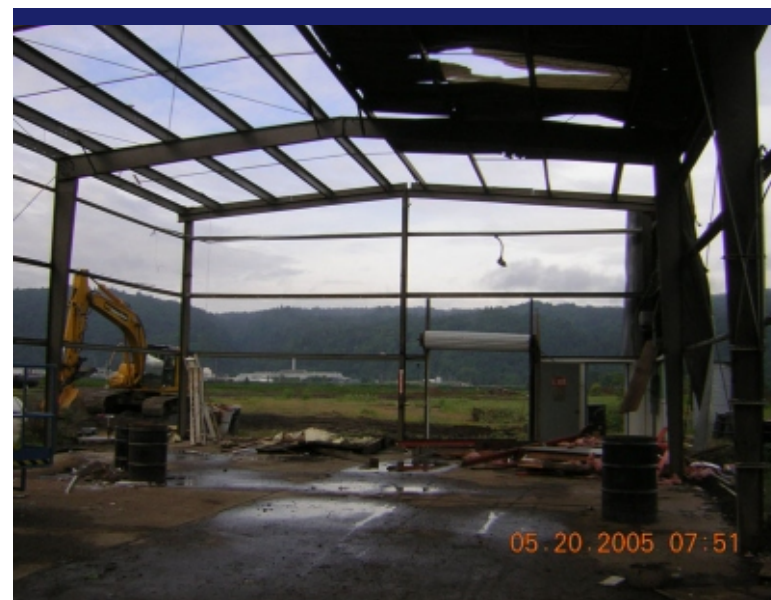
Photo 4 Shop building with siding removed.
Direction: West

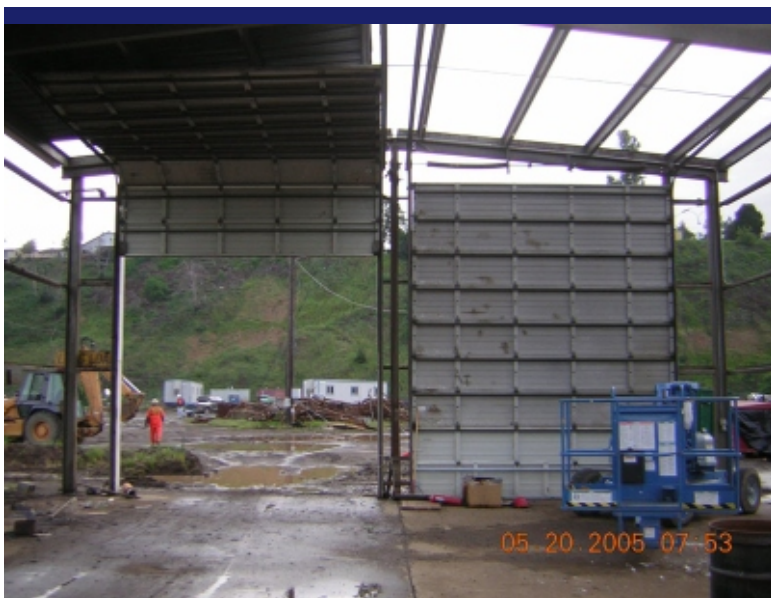
Photo 5 Shop building with siding removed.
Direction: East

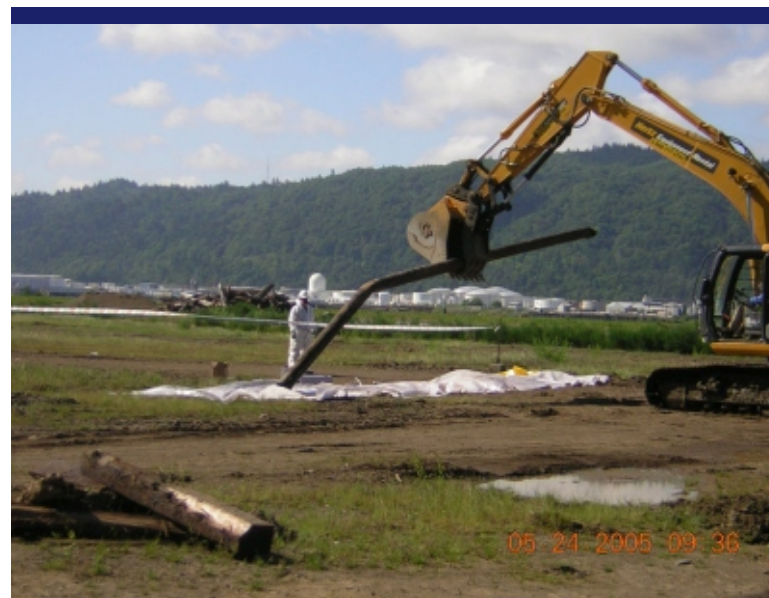
Photo 6 Asbestos pipe being placed on 6 mil plastic sheeting as part of the asbestos abatement.
Direction: West

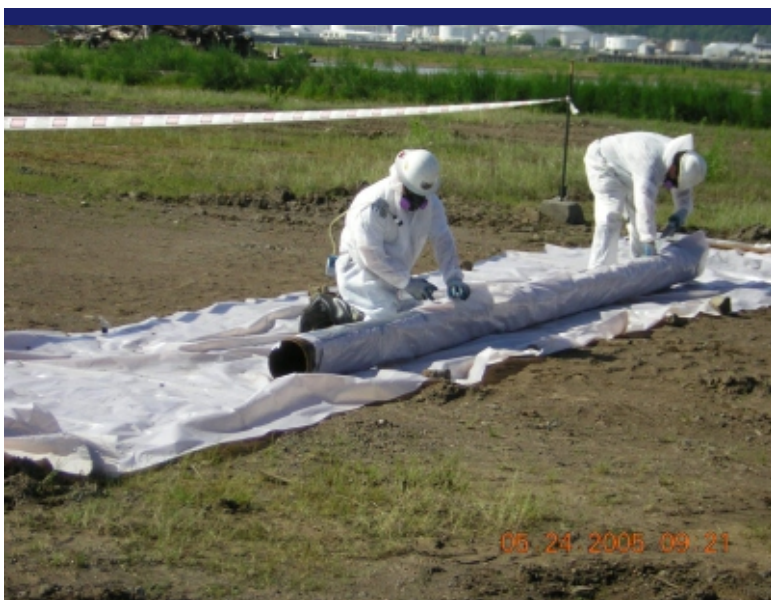
Photo 7 Asbestos pipe being wrapped by PAS, Inc. in two layers of 6 mil plastic sheeting.
Direction: West

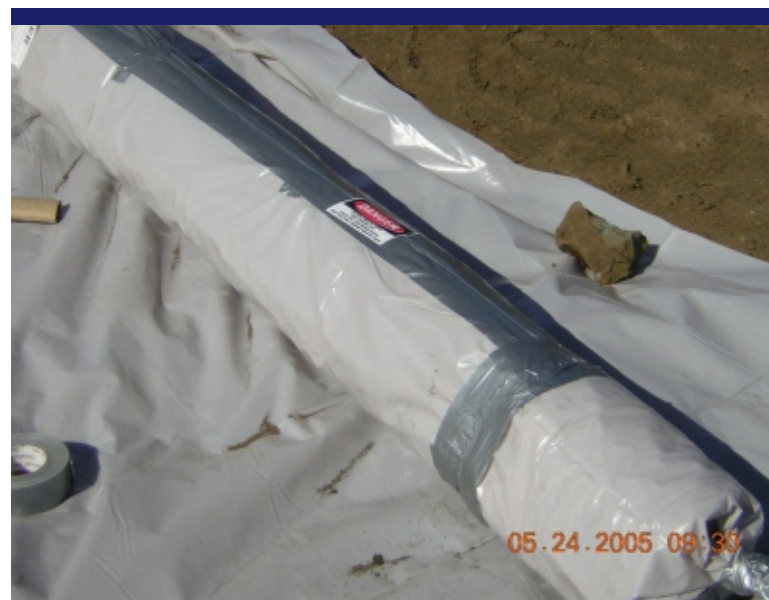
Photo 8 Close up of asbestos pipe completely wrapped in two layers of plastic sheeting.
Direction:

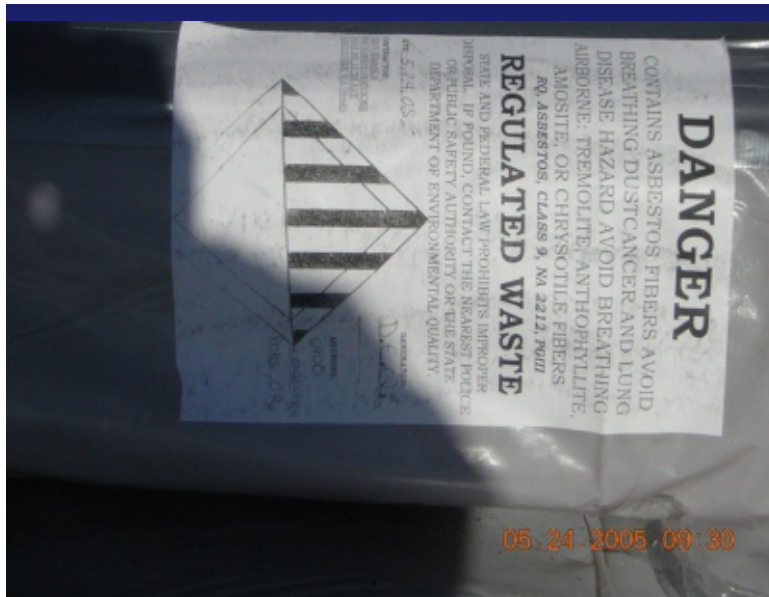
Photo 9 Asbestos hazard label affixed to each wrapped pipe.
Direction:

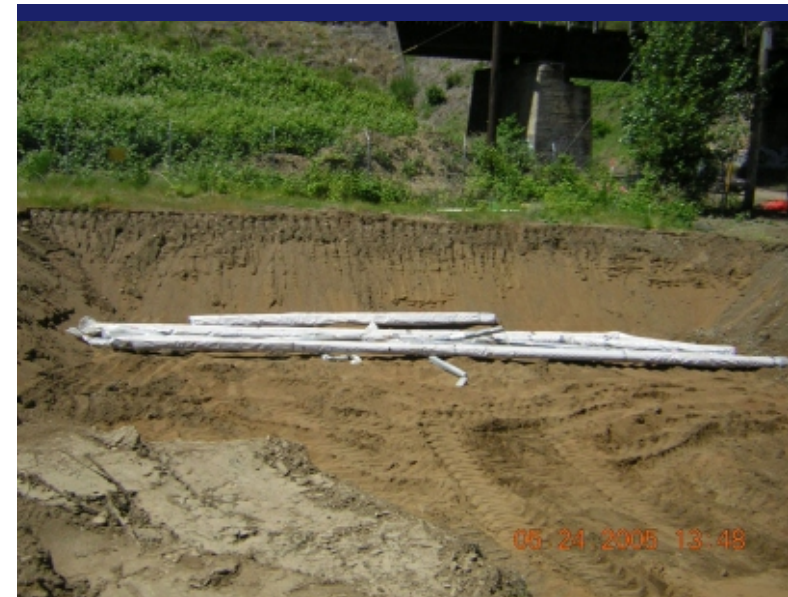
Photo 10 Disposal pit for buried asbestos pipe after it has been wrapped. Located in N corner of site.
Direction: Northwest

- **05/23/05** – Wilder excavates the pit for the disposal of water pipe containing asbestos wrap. Wilder also buries the oversized concrete located at the south end of the site at the pre-determined location. PGE installs the replacement utility pole outside the north fence line.
